LAKE PAHAGACO DAM

PHASE I INSPECTION REPORT

NATIONAL DAM INSPECTION PROGRAM.

Name of Dam: LAKE PAHAGACO DAM
State and State No. PENNSYLVANIA - 67-484
County Located: YORK
Stream: FIRST FORK BUNCH CREEK, SUSQUEHANNA
Date of Inspection: June 20, 1978

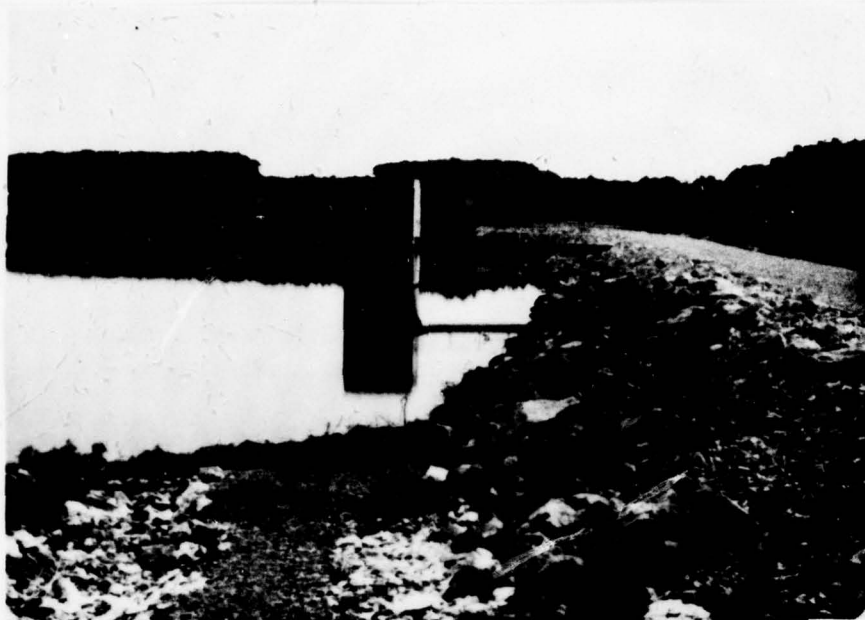
OVERVIEW
UPSTREAM
SLOPE

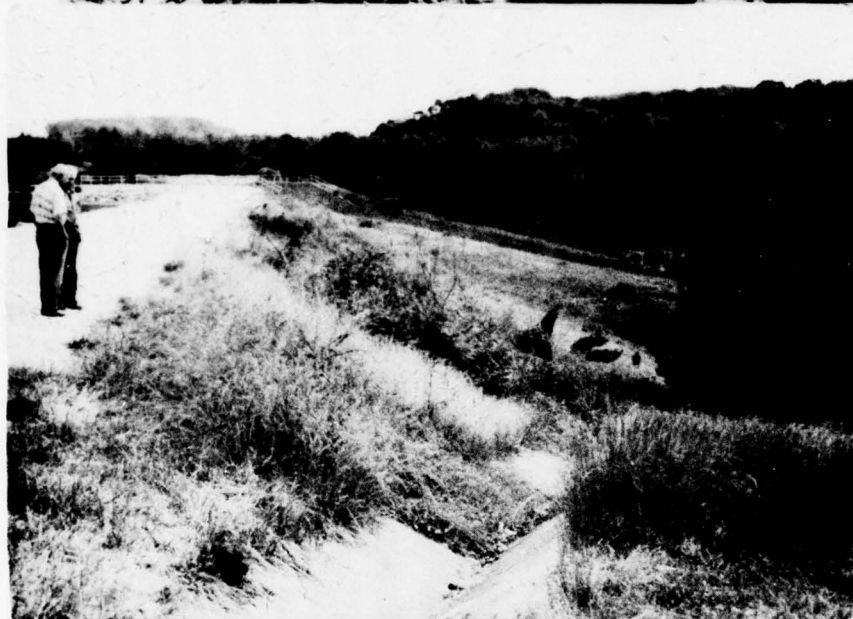
There are no visual indications of settlement or sloughing of the embankment slopes. There is, however, a sizable area of the downstream slope which was found to be wet during this inspection (June 20, 1978). The heavy growth on this slope makes it difficult to define the limits of this condition. Considerable records have been kept regarding leakage at the outlet structure and from the toe of the slope, up to 1978. Reference to slope seepage, however, has not been found in any of the available information. Removal of the growth on the downstream slope and further examination and study of this condition is recommended. The wet area on the downstream slope is of concern.

The inspection of the dam revealed a wet condition high on the downstream slope indicating seepage across the area. The heavy growth of weeds on the downstream slope makes it difficult to define the limits of this condition. Additional investigations to establish the source of this wet condition as well as its extent should be initiated by the owner.

Tall grass and brush on downstream slope made it difficult to observe slope condition. Wet areas were detected by carefully walking and pressing firmly onto the slope with one's foot.

DOWNSTREAM
EMBANKMENT

1. The the source and effect of seepage on the downstream slope be thoroughly investigated by the owner's consultant.
2. That the seepage from the toe and around the conduit be continued to be monitored on a monthly basis and be evaluated along with the slope seepage condition.
3. That the six foot weir across the outlet channel be reconstructed and monitored as part of the overall seepage investigation.

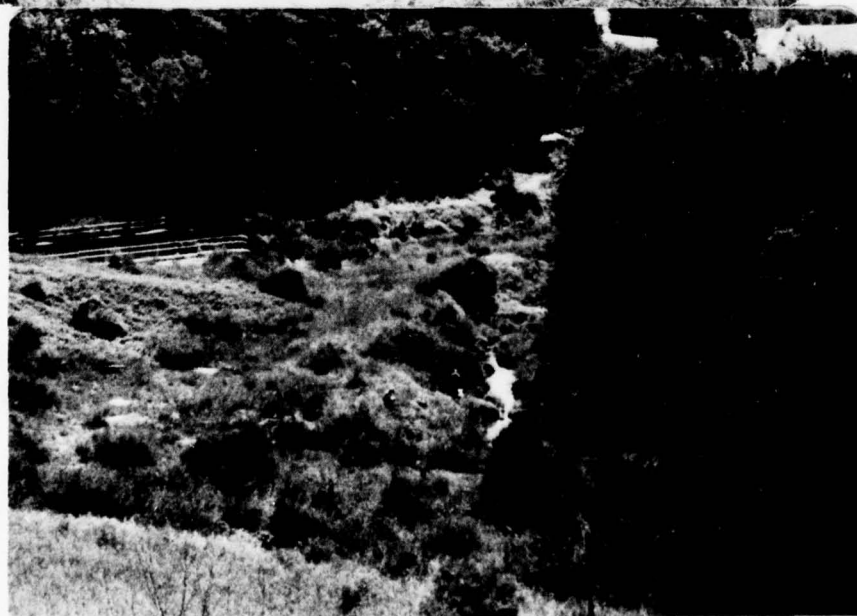
SPILLWAY &
CONDUIT
OUTLET

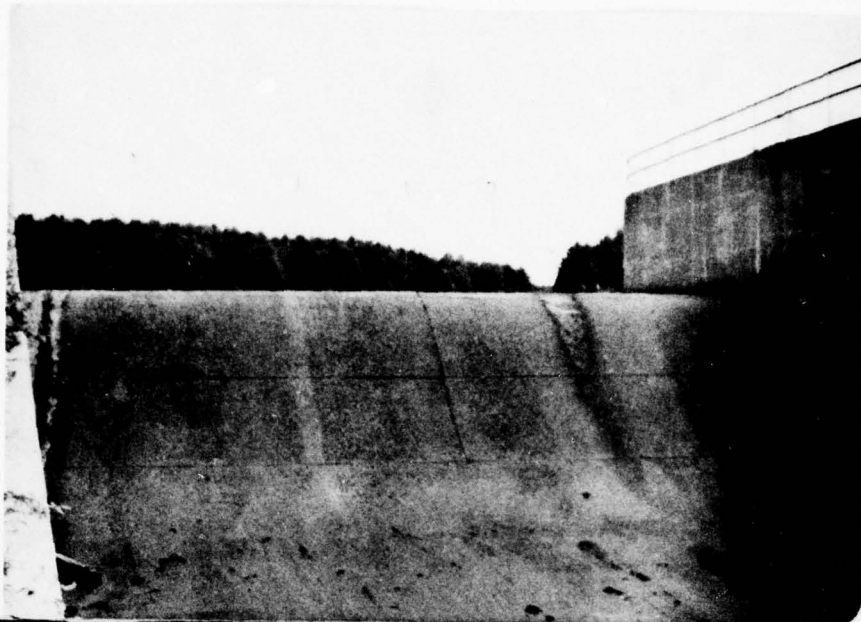
The spillway is in excellent condition as are the walls and slab of the spillway channel and the stilling basin.

SPILLWAY
WEIR

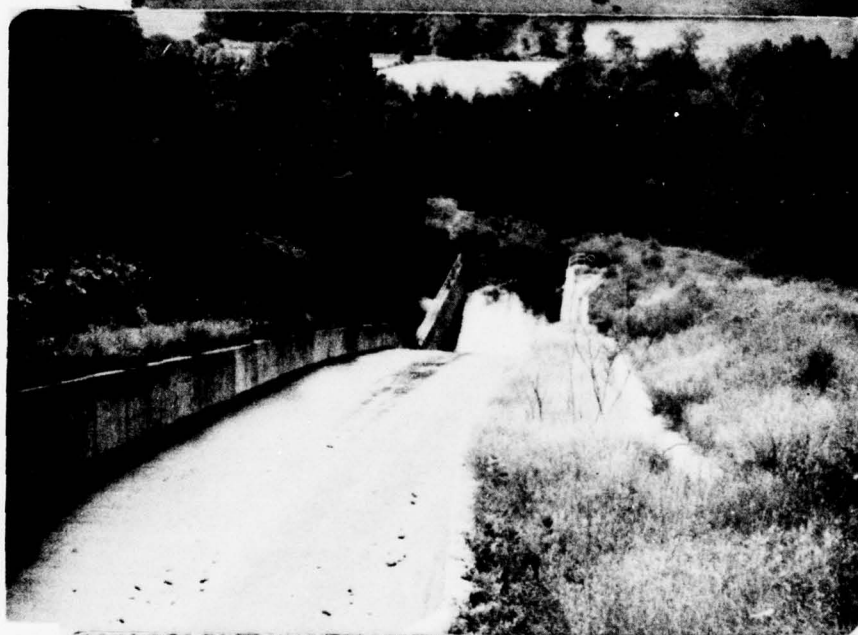
SPILLWAY
CHUTE

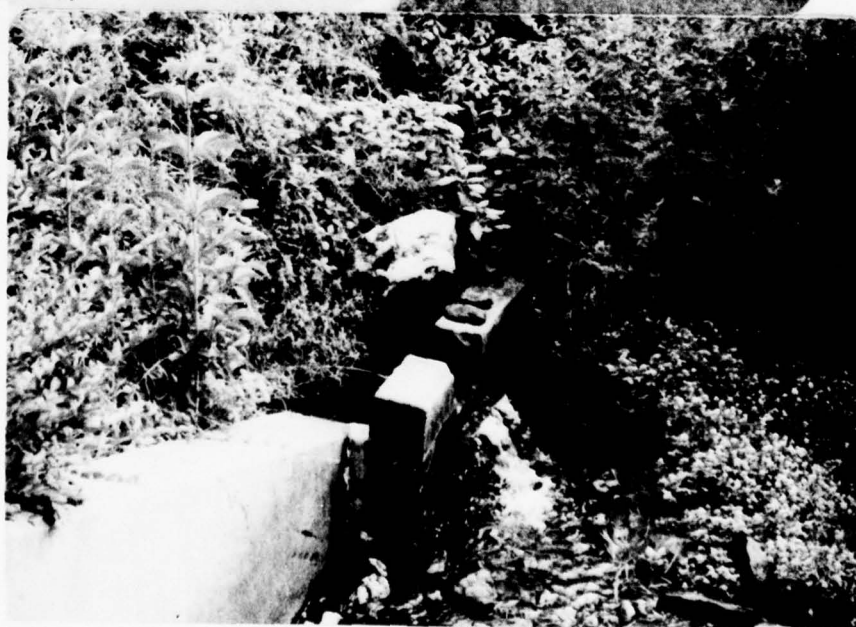
PLATE IV

Three concrete weirs are located in the area of the outlet structure. Another deteriorated wooden weir is located across the outlet channel. It is not operable.

CONDUIT
WEIR
